READING PIPE

GENUINE Wrought Iron

READING IRON COMPANY
READING, PA.

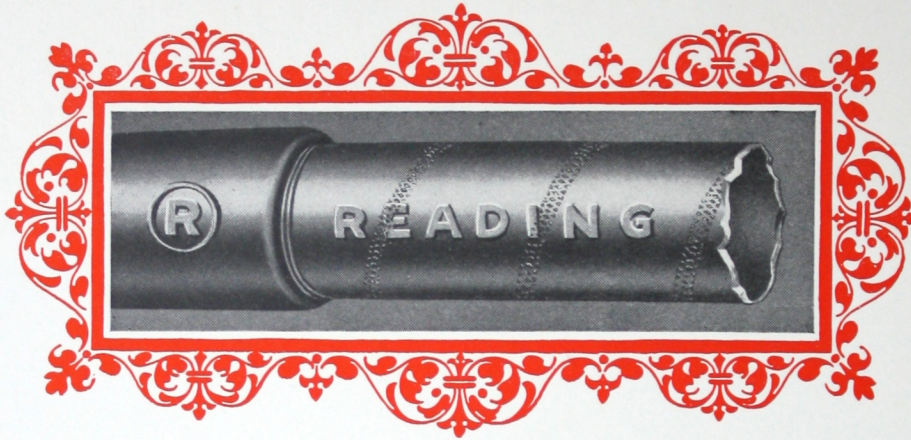
Look for the Reading' Spiral Knurl Mark

Every Foot of Reading Genuine Wrought Iron Pipe is positively and permanently identified by the Reading Spiral Knurled Mark. The name READING and the year of manufacture are also rolled in the metal on every length. Each Reading Nipple bears the Reading Knurled Mark for your positive identification.

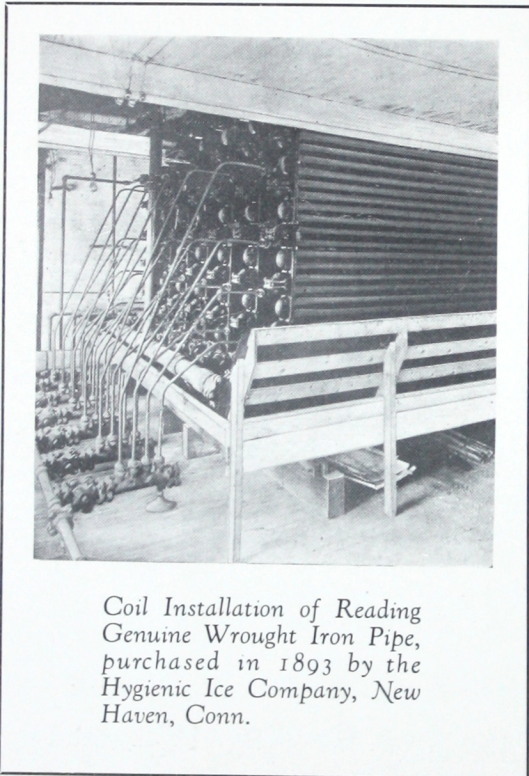
Coil Installation of Reading
Genuine Wrought Iron Pipe,
purchased in 1893 by the
Hygienic Ice Company, New
Haven, Conn.

WAY back in 1892—when bicycles and buggies were the only joy-riding devices and Harrison was President, the Hygienic Ice Company of New Haven, Conn., had six atmospheric condensers installed.

Actual operation of the plant began just after Grover Cleveland was inaugurated President in 1893. These condensers operated continuously until 1921—without a break or a leak.

Then the whole battery of 20 condensers were subjected to a 300 lb. hydrostatic test. The old 1892 pipes stood up just as well as the 1926 Pipes!

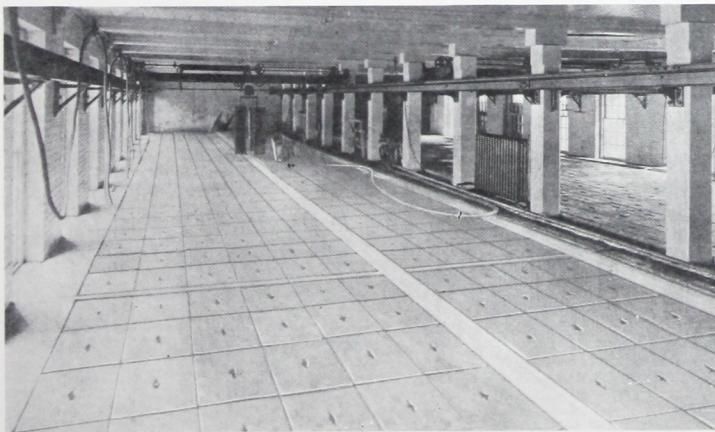
A Tank Room at the Hygienic Ice Company. Coils still perfect after 34 years of submergence in brine.

In 1893, two 25-ton ice tanks were also installed in this plant, each containing 440-330 lb. cans. The coils in these tanks were made of Reading Genuine Wrought Iron Pipe, and have been in continuous operation since that time—only one length has been removed on account of a small pin hole leak.

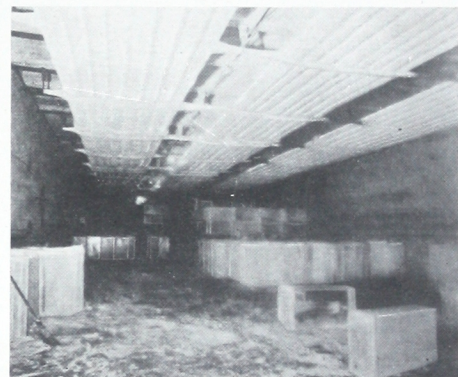
Main Ice Storage Room, Hygienic Ice Company, 2" extra strong Reading Genuine Wrought Iron Pipe in service since 1893.

Coils of Reading Genuine Wrought Iron Pipe were also used since 1893 in the cold storage plant formerly operated in conjunction with the Ice Plant. They were removed and are now giving excellent service in a new Ice Storage room, recently erected.

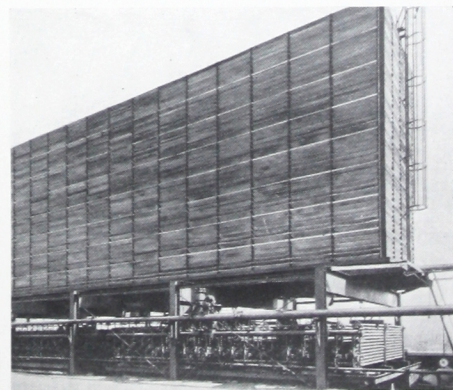
Condenser at Plant of Hygienic Ice Company, showing coils of Reading Genuine Wrought Iron Pipe in constant service since 1893.

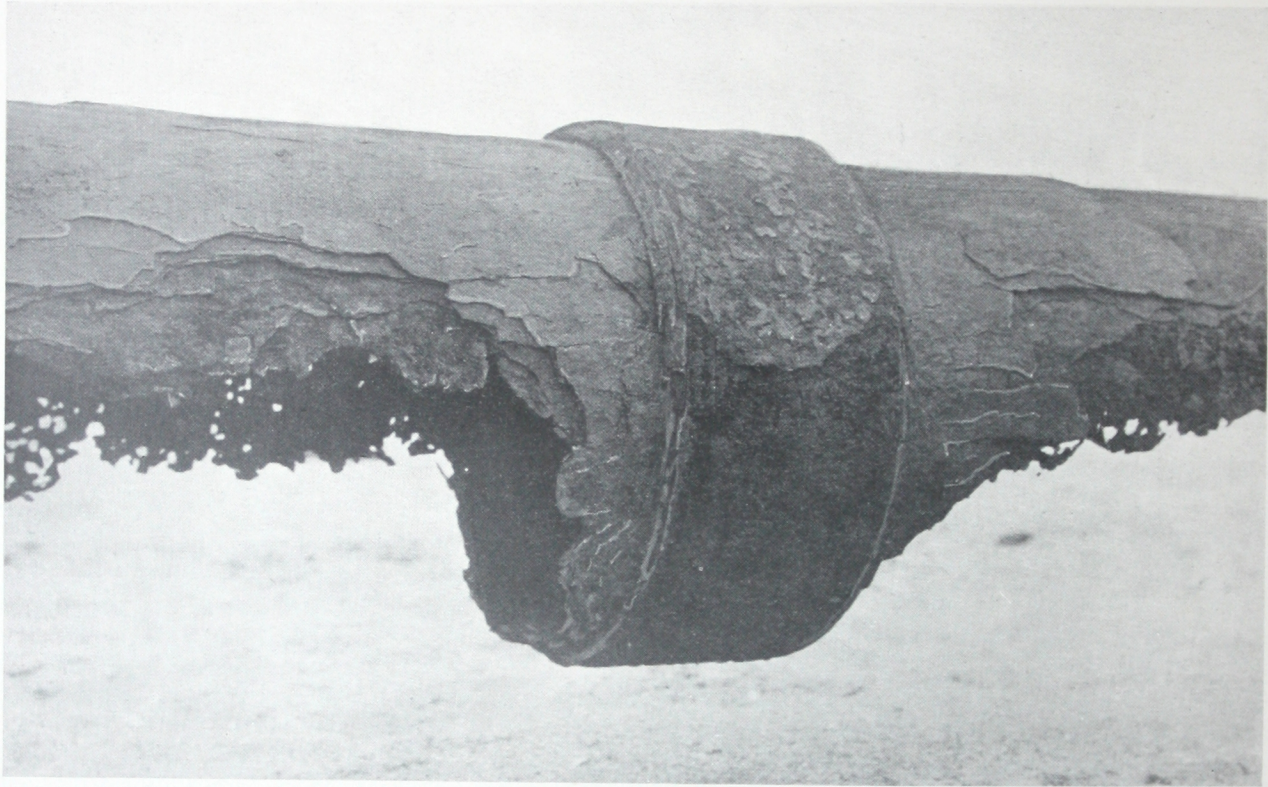
STEEL PIPE HELD TOGETHER BY
*Wrought Iron Coupling, after
10 Years at Spring Lake, N. J.*

THIS photograph demonstrates the difference between Genuine Wrought Iron and steel more conclusively than any laboratory test ever made.

Note that the coupling of Genuine Wrought Iron is still in an excellent state of preservation, while the steel pipe is reduced to a shell.

Reading Genuine Wrought Iron Pipe contains a siliceous slag content which resists corrosion—forms a barrier against rust. This slag encases the pure iron and the processes of manufacture (see “Reading” Bulletin No. 1) give Genuine Wrought Iron its fibrous, rust-resisting structure.

Because steel is homogeneous in structure and does not contain slag, corrosion will never find in steel pipe a barrier against destructive conditions.

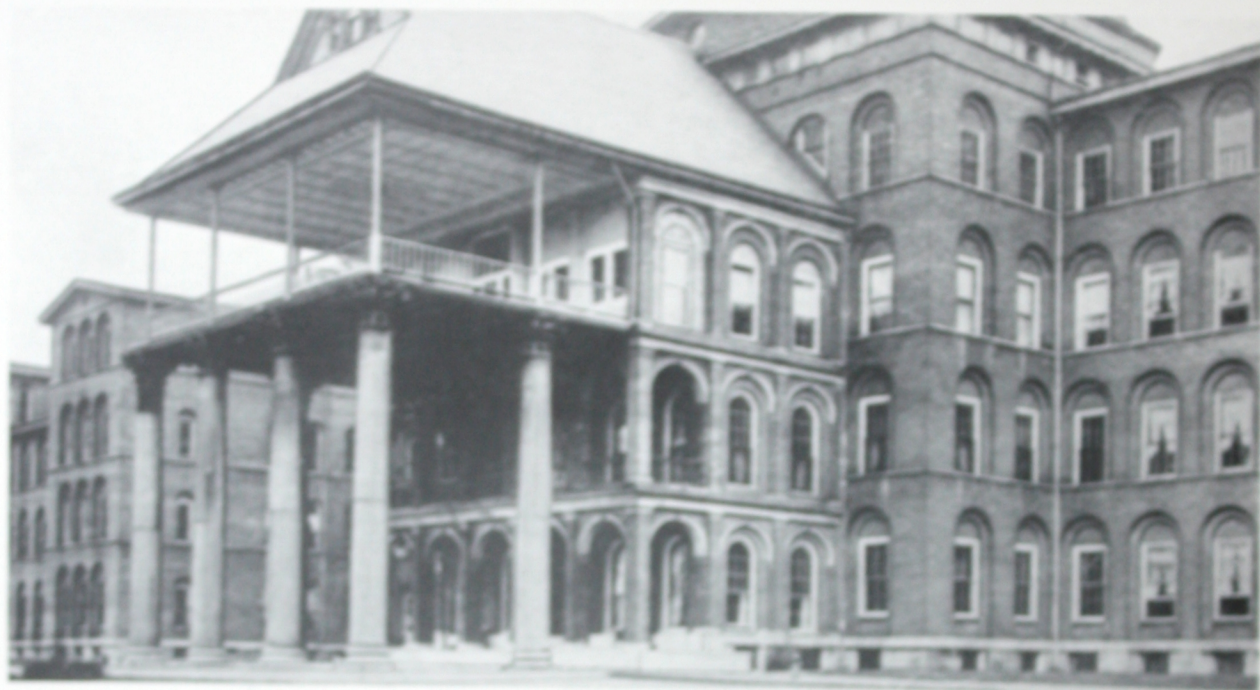
ACTIVE SERVICE FOR 44 YEARS

BEFORE THE CIVIL WAR, THE LONGVIEW Hospital, Cincinnati, Ohio, was caring for the sick. When originally built in 1860, Cast Iron Pipe was used throughout

IN 1882, 44 years ago, Reading Genuine Wrought Iron Pipe was installed. The Hospital then forgot all about pipe until 2 years ago, when some changes were made in the pipe line.

At that time all the Reading Pipe was found to be in such good condition that it was USED AGAIN. Not one length of Reading Pipe was found that had outlived its usefulness.

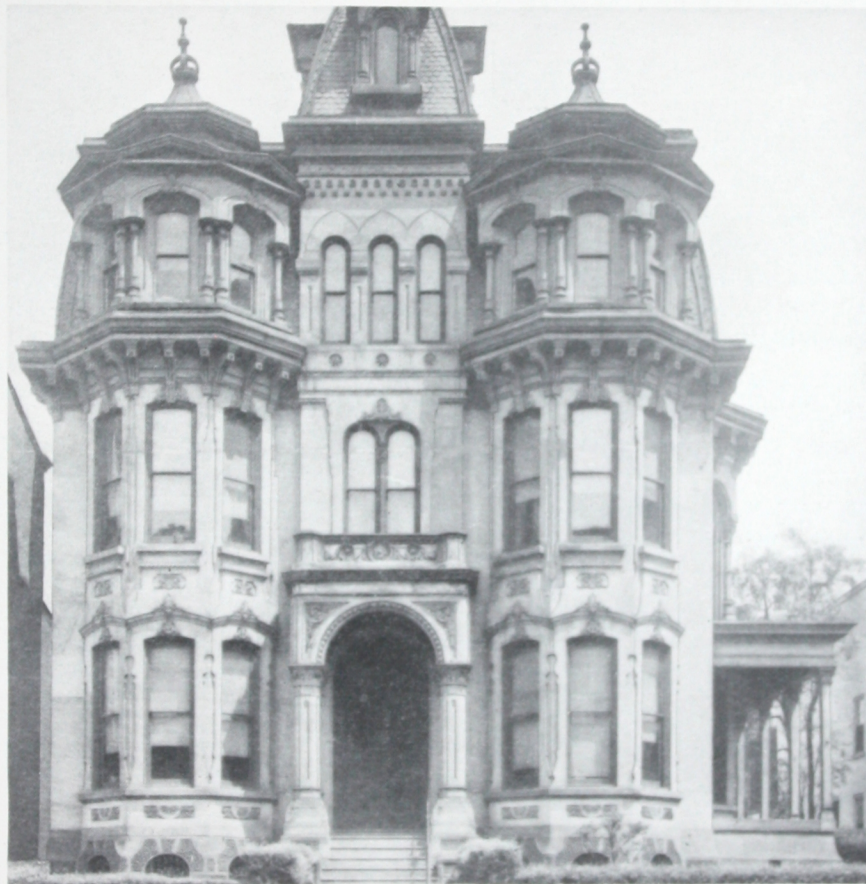
Built about 1872, this old Reading home combined substantial construction, architectural beauty and those comfortable features which we now call "old fashioned" but are of more enduring worth than many newer ideas.

In 1926, when the March of Progress necessitated the demolition of this old residence — fifty-four years after its installation — the Genuine Wrought Iron Pipe was found to be in excellent condition.

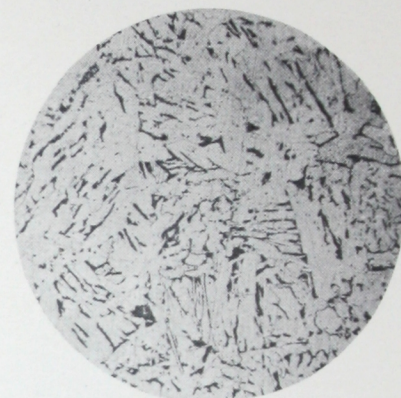
FIG. No. 1
Steel Pipe — note the absence of long filaments of protective slag.

over .050%, usually a sure indication of the addition of steel scrap. Compare Photo No. 2 self-styled "Wrought Iron" pipe with Photo No. 1—Steel pipe—and note the very close resemblance.

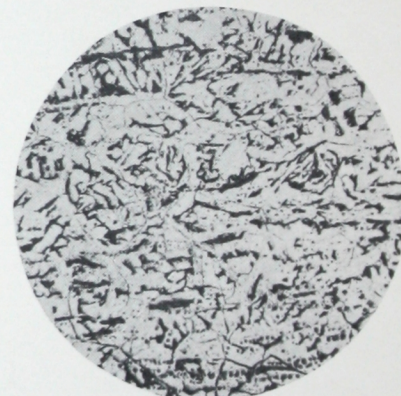
FIG. No. 2
A self-styled "wrought iron" pipe. Steel scrap used. Note the close resemblance to steel.

Several so-styled "wrought irons" on the market are made by using old junk-yard scrap which is busheled or fagoted, heated to a welding heat and rolled into skelp for making pipe. Pipe made from junk-yard scrap today consists mostly of steel as shown in photomicrograph No. 2.

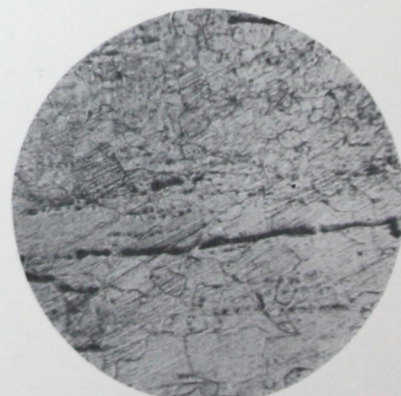
FIG. No. 3
Another manufacturer's product, called "wrought iron" but far different from the genuine.

Other so-called "wrought irons" are made of mixtures of busheled steel and iron rolled into bars which are piled with bars of a little better grade of material heated to a welding temperature and rolled into skelp for pipe, as photomicrograph No. 3.

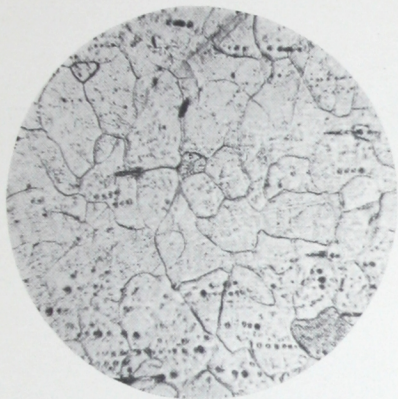
FIG. No. 4
A so-called "wrought iron" pipe — inferior because of its low slag content.

As shown by Photos No. 4, another so-called "Wrought Iron" pipe, and No. 5, the misnamed "Wrought Iron" of another manufacturer, this material is not made from puddled pig iron but contains only traces of silicon and is very low in slag. Genuine Wrought Iron contains sufficient non-corroding siliceous slag to impart to its structure the many virtues it is known to possess, while the slag found in samples No. 4 and No. 5 is an iron oxide which does not possess any value and is really a detriment and accelerator of corrosion.

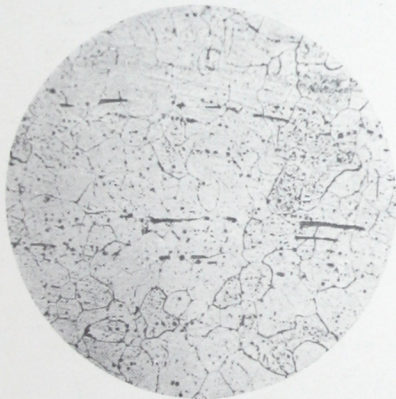
FIG. No. 5
Product of another manufacturer. Scrap has been generously used.

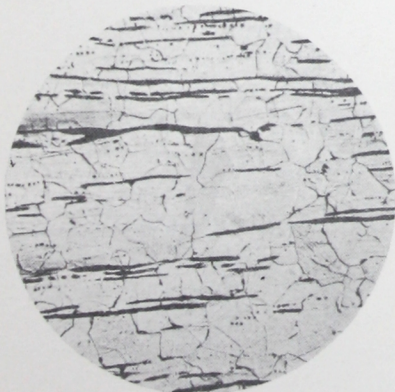
FIG. No. 6
Reading Genuine Wrought Iron Pipe. The difference is easily seen. Long filaments of slag form a series of long barriers against corrosion.

Photomicrograph No. 6, Reading Genuine Wrought Iron, is a metal made up of innumerable fibres surrounded by slag filaments and has within itself the power of distribution of strains and stresses. The superior corrosion-resisting qualities of Genuine Wrought Iron are shown clearly in the many splendid examples of wrought iron bridges, fences, pipes, and parts of old locomotives and cars that have withstood the elements for over half a century and are still in excellent condition.

There are several hundred thousand slag filaments in one inch square cross section of wrought iron and being non-corrodible they will obstruct the progress of corrosive attack.

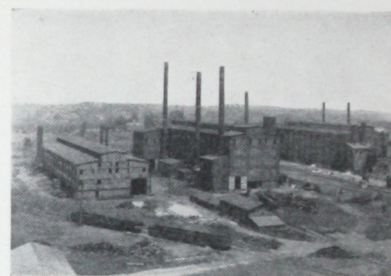
Roe Puddling Department for the manufacture of Reading Genuine Wrought Iron Skelp from which pipe is made.

1. Reading Genuine Wrought Iron is made in a Puddling Furnace. Puddling is a process for the production of Wrought Iron from pig iron by the action of flame assisted by agitation, whereby most of the foreign elements are removed by oxidation. Vigorous agitation of the mass is employed throughout the whole process.

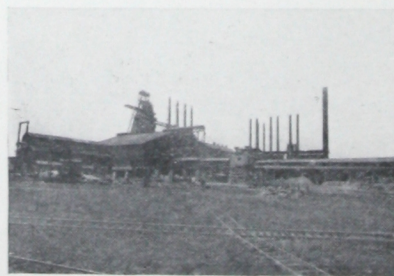
Keystone Furnace where Pig Iron used in the manufacture of Reading Genuine Wrought Iron Pipe is produced.

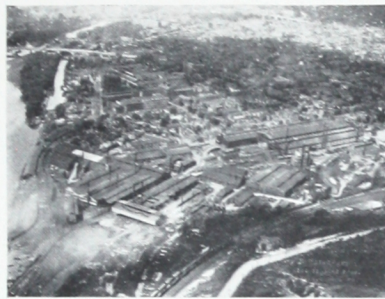
Tube Works Department where Genuine Wrought Iron Skelp, made by "Reading" from "Reading" raw materials, is welded into tubular goods in diameters from $\frac{1}{8}$ " to 20"

weld processes. In the former the skelp is drawn into a bell shaped tube, and welded edge to edge. In the lap weld process the edges are scarfed, the overlapping pieces are welded with a uniform thickness throughout. The double welding process improves the quality of Reading Pipe and the efficiency of its welds. Conclusive tests have demonstrated that the weld of Reading Genuine Wrought Iron is the last part to weaken.

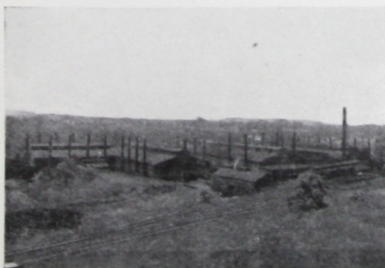
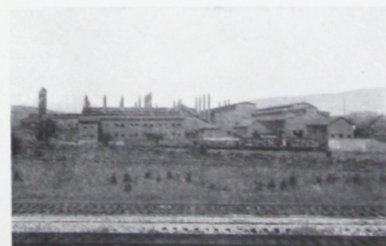
Skelp Mill for the production of Reading Genuine Wrought Iron Pipe.

4. Genuine Wrought Iron skelp (long flat iron strips from which pipe is welded) is made from bars of puddled iron, without the addition of any other material except our own crop ends of pipe (permitted under all standard specifications for Genuine Wrought Iron Pipe.) These piles are heated at a uniform temperature so as to weld all together in the rolling operation.
